**Final Report**

**FLIGHT SAFETY FOUNDATION, INC.**

September 1961

Prepared by  
Aviation Crash Injury Research  
A Division of  
Flight Safety Foundation, Inc.  
2871 Sky Harbor Blvd.  
Phoenix, Arizona

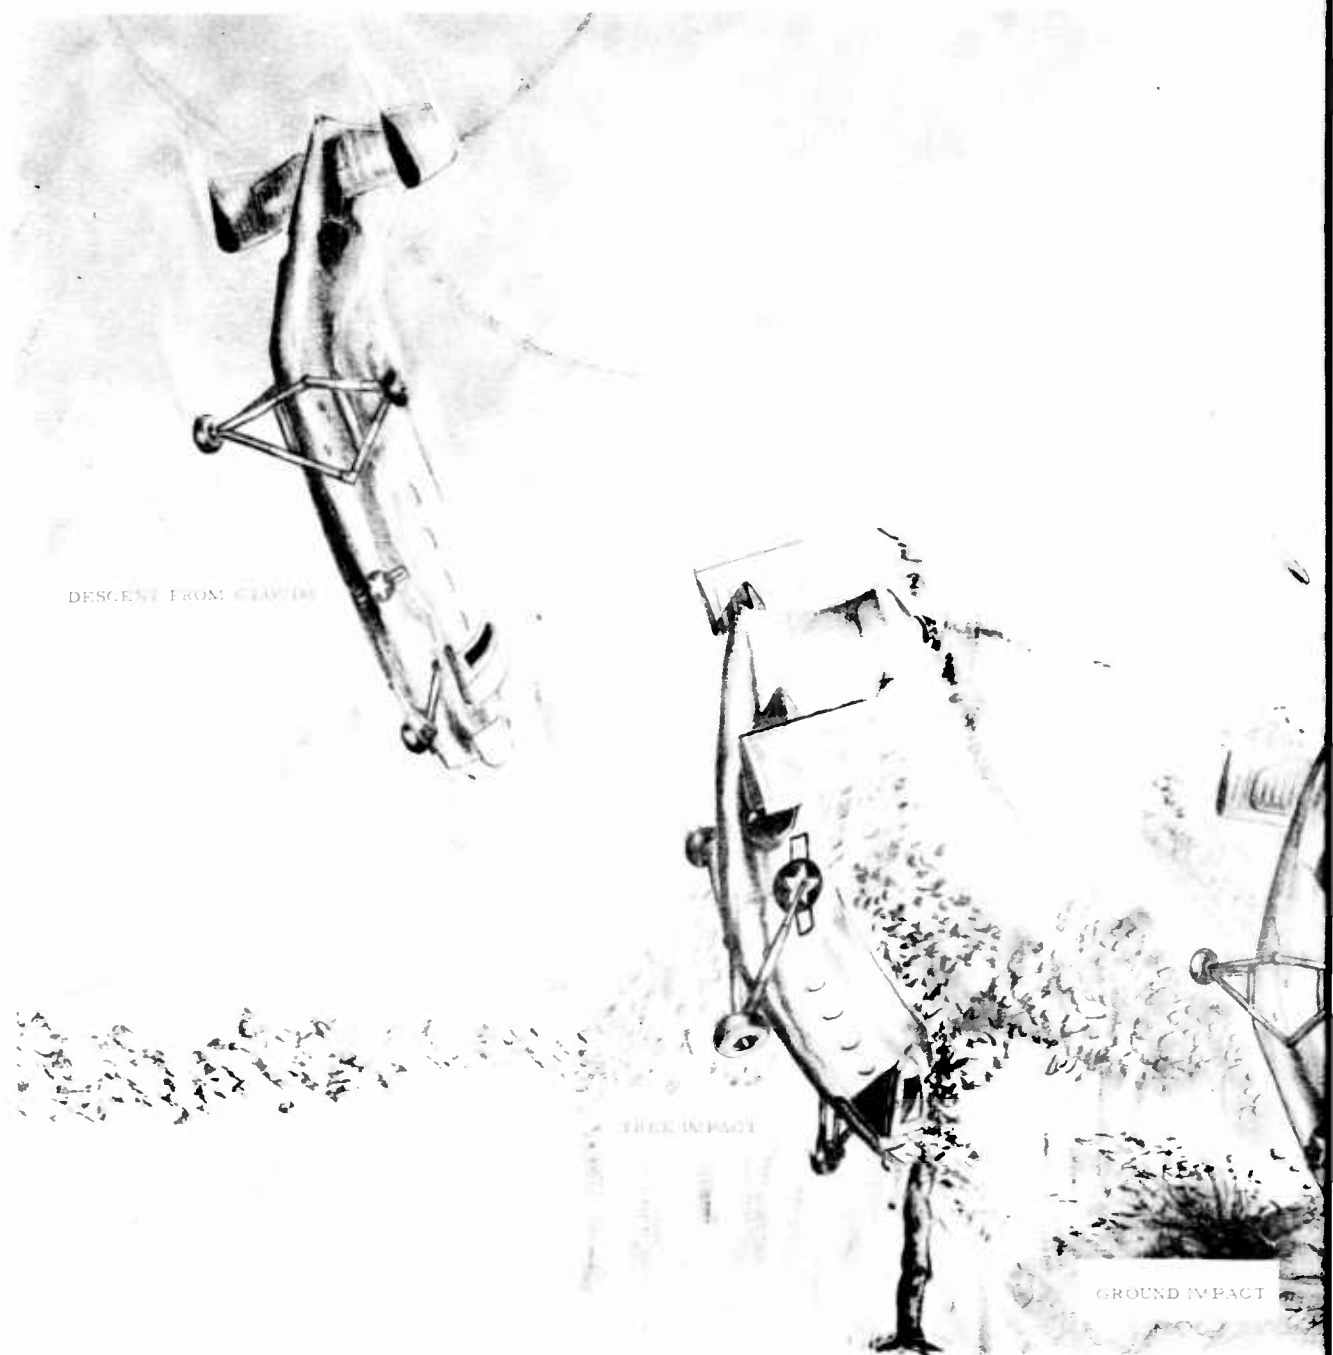
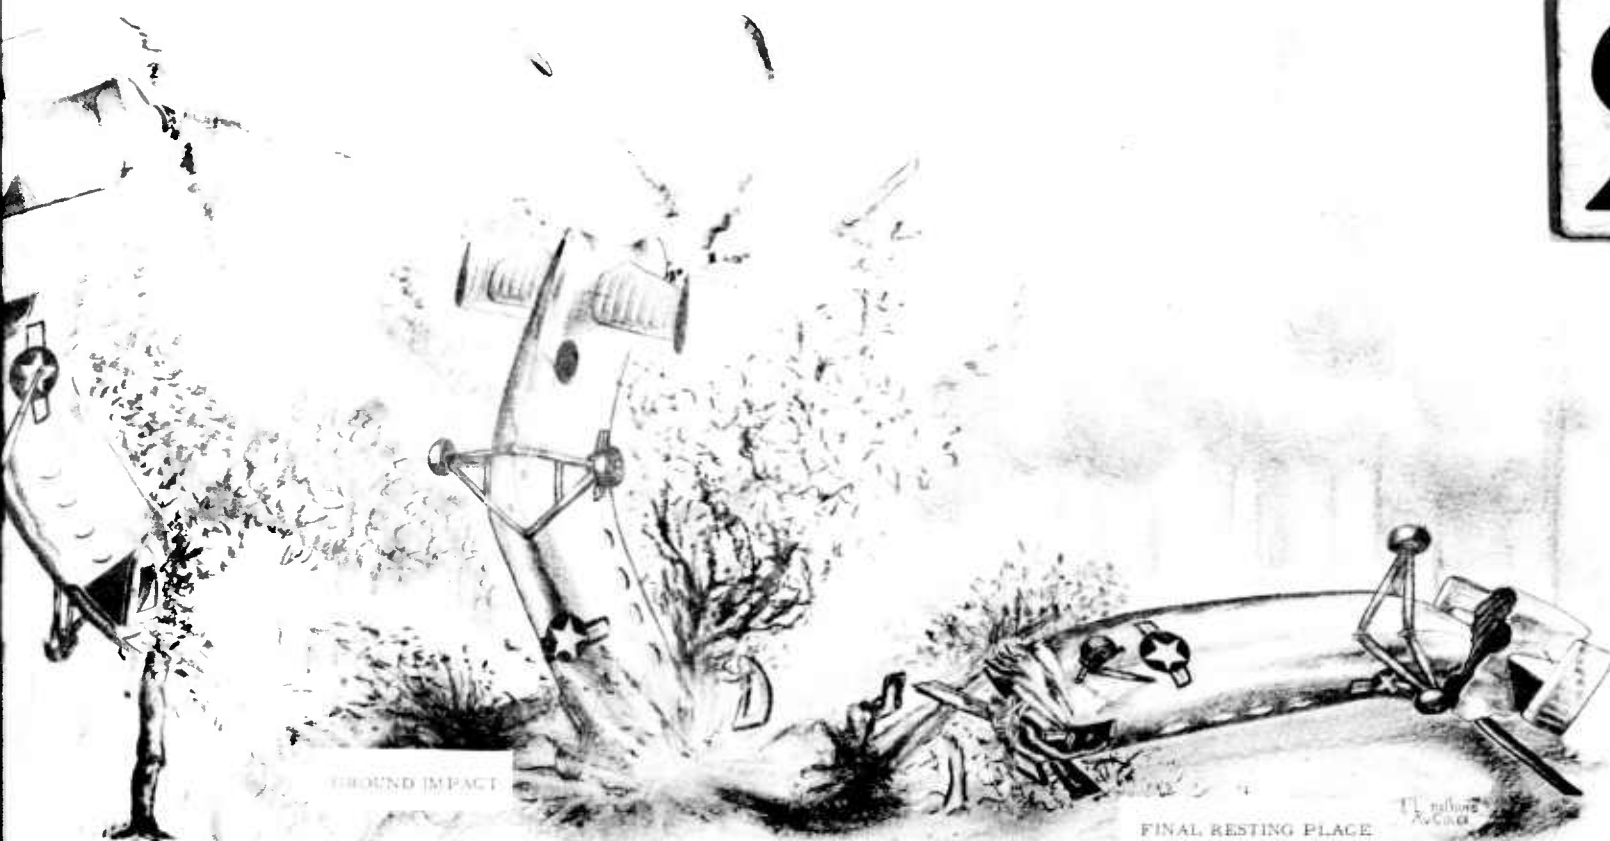
The fuselage received very little damage, and the tail pylon sheared off from striking boulders. The main concentration of force was on the right front cockpit area - the occupiable area being reduced by approximately 65 percent during penetration by the forward transmission and rotor head.

From the investigation it was concluded that since the occupiable area of the pilot had been reduced approximately 65 percent, survival by the pilot would have been questionable had he remained in the cockpit. The pilot seat attachments failed at all four connecting points due to impact forces. The copilot seat attachments failed at two points but the seat and occupant remained in place.

Figure 1. Kinematics of Crash Sequence of H-21C

Diagram of Crash Sequence of H-21C, Tobyhanna, Pennsylvania.

1. The seat tiedown structures of the pilot and copilot seats in the H-21 should be redesigned to prevent failures under survivable crash force applications, and the occupant restraint devices (seat belt and shoulder harness) should be anchored to the primary structure.
2. The transmission support structure in this type aircraft should be designed to prevent the transmission from being displaced into the occupiable area of the cockpit during

3. Every effort should be made in the design of future aircraft to route the drive shafts outside the occupiable areas.
4. Consideration should be given to the use of an improved chin-strap attachment as a modification to the APH-5 crash helmet.
5. A nonshattering material should be utilized for sun visors on the APH-5 helmet.
6. Litter brackets should be redesigned so that they can be stowed flush with the cabin wall when not in use.
7. Crew members and passengers again should be made aware of the potential hazards of loose equipment within the occupiable areas of an aircraft.

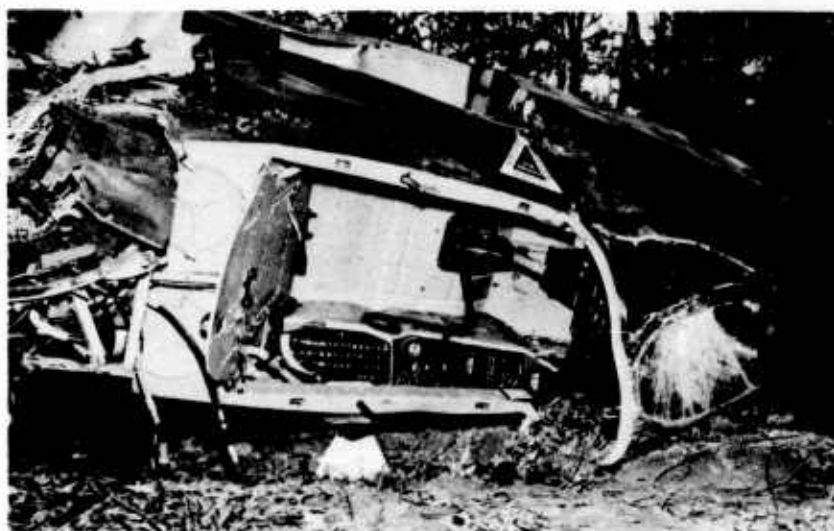
The pilot died 3 days after the accident, the fatal injury being caused by a blow to the head. It was judged that this occurred when the pilot's head was thrown so that it projected over the side of the

cockpit as the aircraft went through the trees, resulting in a heavy blow on the front of the APH-5 crash helmet.

Figure 2. G-91 Reconnaissance Jet Fighter Accident.

1. The cockpit structure, by remaining relatively intact, provides a good crashworthy environment.
2. The ejection seat, designed to provide safe escape at all altitudes and speeds, should be utilized as an escape device except possibly when crash-landing on a well-prepared surface or runway.
3. Further study should be given to the effectiveness of the APH-5 helmet, particularly to the effects of improper sizing or fitting.

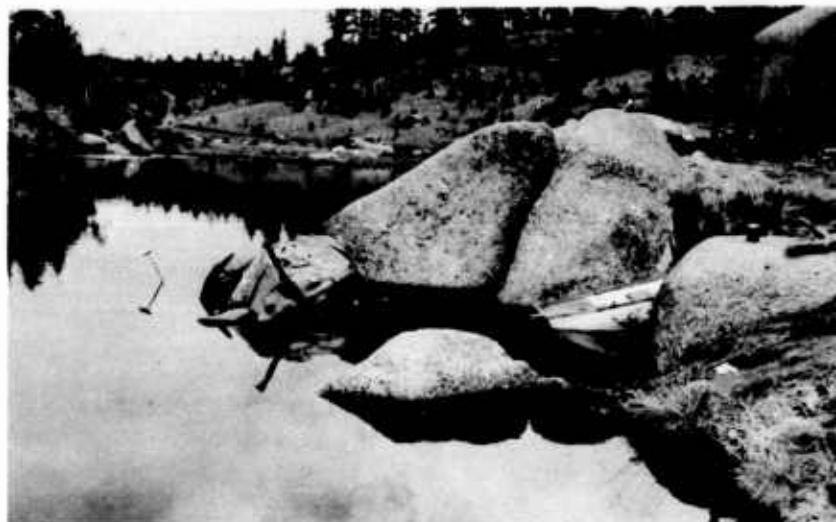
Figure 3. HU-1A Helicopter Accident Site, Fort Carson, Colorado.

Army personnel arrived at the scene of the crash to find the wreckage partially submerged at the edge of the lake. The pilot was found in front of the wreckage with fatal impact injuries. The copilot, still strapped in the seat, was found, expired, floating in the lake. Later autopsy revealed a lacerated aorta. One lifeless passenger was found between the wreckage and the shore. A second lifeless passenger had been trapped in the submerged wreckage.

Examination of the wreckage revealed definitely nonsurvivable conditions for the pilot and copilot and showed only slightly better conditions for the passengers who were compressed between the crushed floor and aft bulkhead. Due to patterns of restraint system failures and other findings, the following recommendations were made:

1. The cast fittings in the occupant tiedown chain should be replaced with materials possessing high-percentage elongation properties. Stock materials such as 2017 aluminum, 4130 chrome-molybdenum steel, and 301 stainless steel, offer much better elongation values combined with reasonable strength-to-weight ratios.

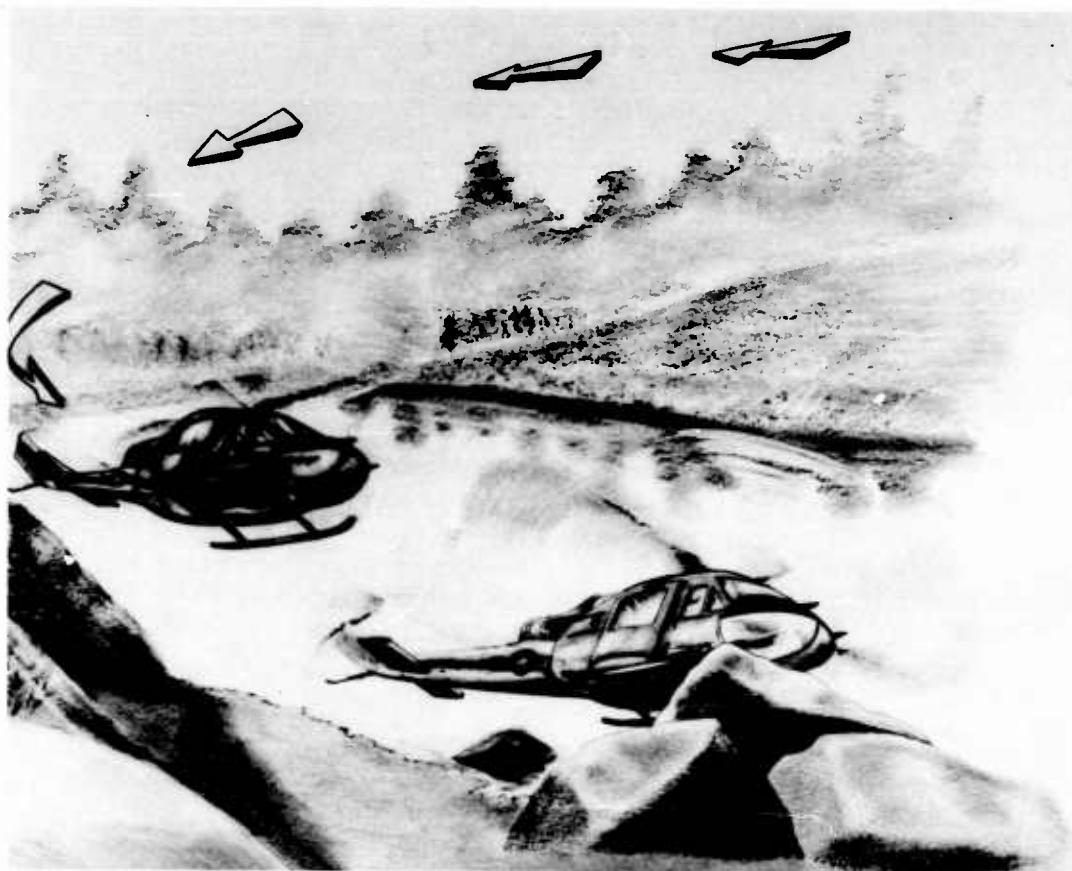
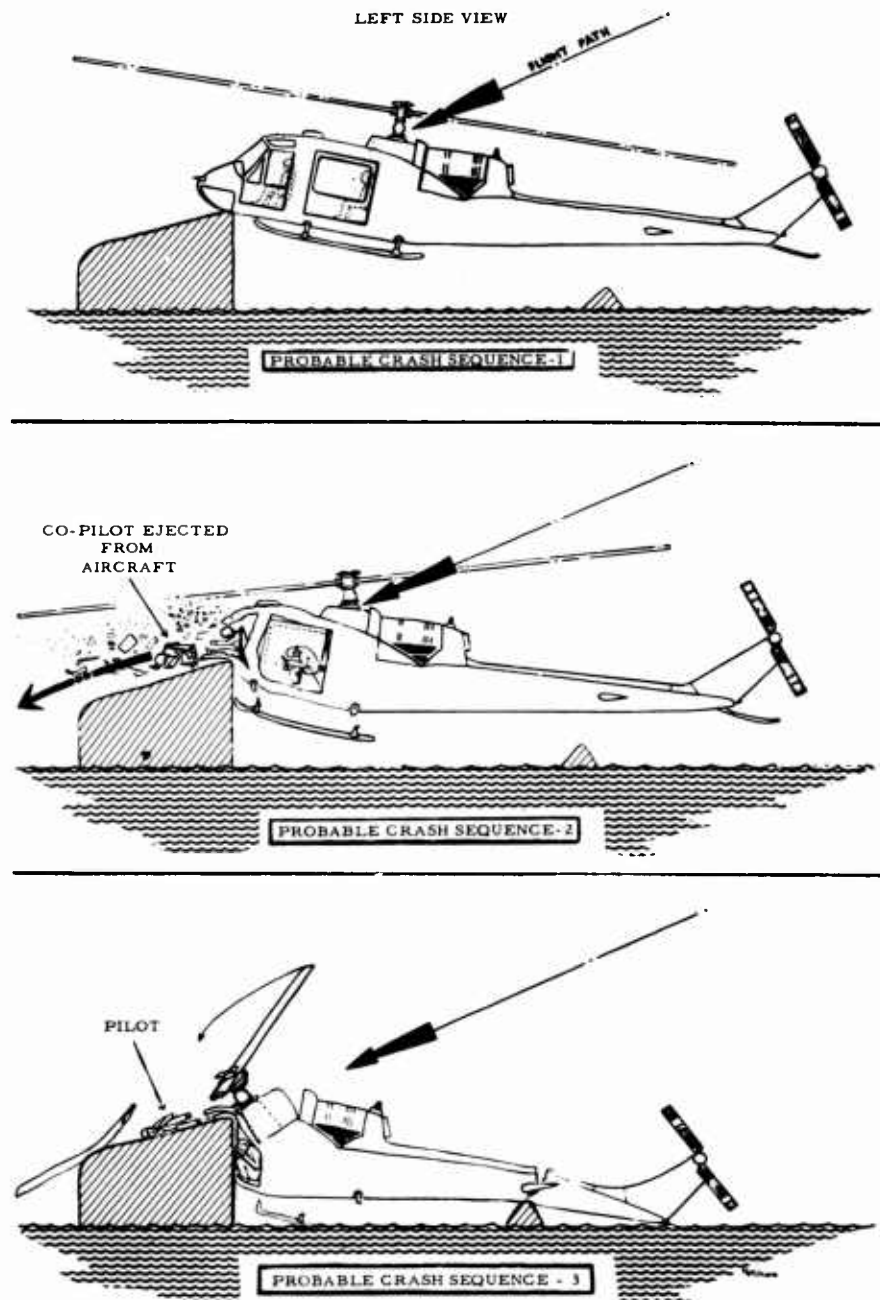
Figure 4. HU-1A Helicopter Accident Kinematics,  
Fort Carson, Colorado.

Figure 5. HU-1A Helicopter Probable Crash Sequence, Fort Carson, Colorado.

2. Seat-belt anchorages should provide self-alignment in a manner which prevents amplification of applied loads regardless of the crash force direction.
3. To utilize the protection offered by the APH-5 helmet to the greatest extent, the chin strap must be reinforced.
4. To improve helmet retention, the nape strap of the APH-5 helmet must be made adjustable.

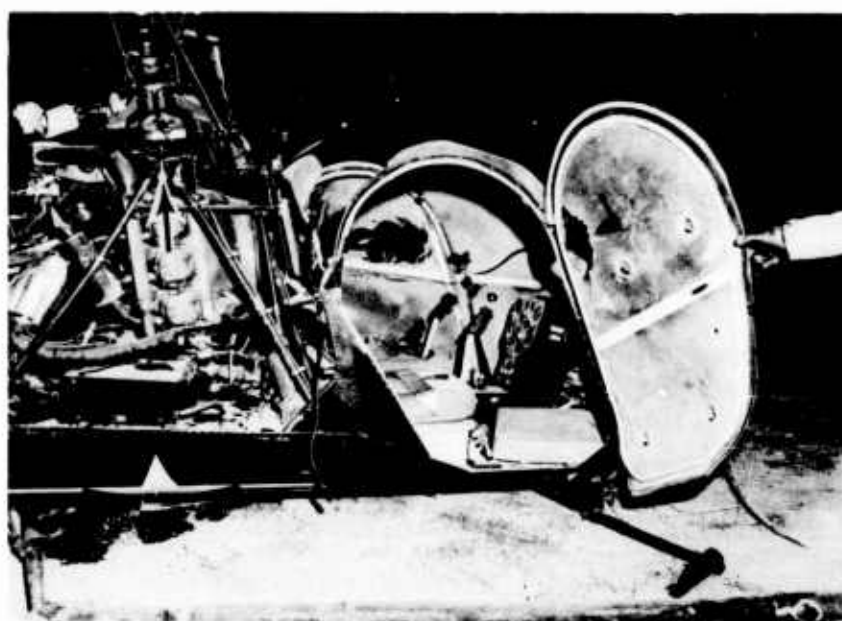
Figure 6. H-23C Helicopter Accident, Phoenix, Arizona.

During one of these runs, the aircraft struck the ground slightly nose down in a gentle left turn. The left skid hit first, followed by the left-front underside of the cockpit floor. At this point the rotors appear to have flexed down into the tailboom, shattering the blades and cutting the tailboom into two main sections. While the helicopter was extensively damaged in this accident, the occupiable area remained relatively intact. The pilot was thrown clear when the safety belt latch opened up and no injuries were sustained.

1. The safety belt, opening as it did, was found to be a model that can be closed without being in a fully locked position. A latch with positive locking action is indicated as a corrective measure.

2. The safety belt was found to be aligned in such a manner that the belt crossed the upper legs rather than at a 45-degree angle across the pelvic region. This could result in serious spinal injury as the result of flexing generally found in this type of accident. Realignment is recommended.

4. Engine mounts failed and the forward displacement of the engine almost impinged upon the occupiable area. Consideration to an improved engine restraint system is suggested.

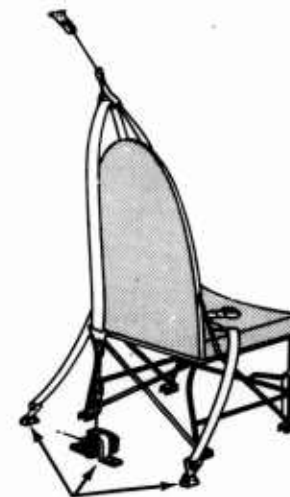
Seat belt and shoulder harness were anchored to the pilot's seat. Consequently, all inertia loads resulting from the crash deceleration were transmitted to the seat-floor anchorages. The two aft leg bolts failed and the seat hinged forward, allowing the pilot to come into forcible contact with structure ahead.

Recommended method for anchoring restraint system.

To reduce the stress on the seat, restraint systems should be anchored to basic aircraft structure. If this is not practicable, the seat structure itself and its anchorages should be designed to withstand the ultimate dynamic loads compatible with survivable impact conditions.

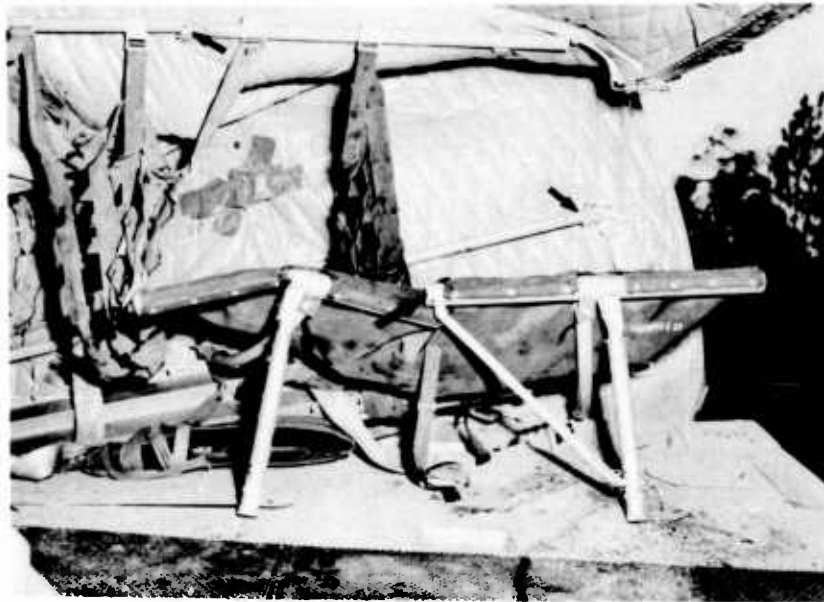
Accident investigations continue to point up serious deficiencies in the applicable specifications, deficiencies that definitely contribute to troop seat failures and, in turn, to occupant injury (References 1, 5, 6, 9, 10, and 11). Typical examples are shown in Figures 8 and 9.

Figure 8. Typical Troop Seat Failure.

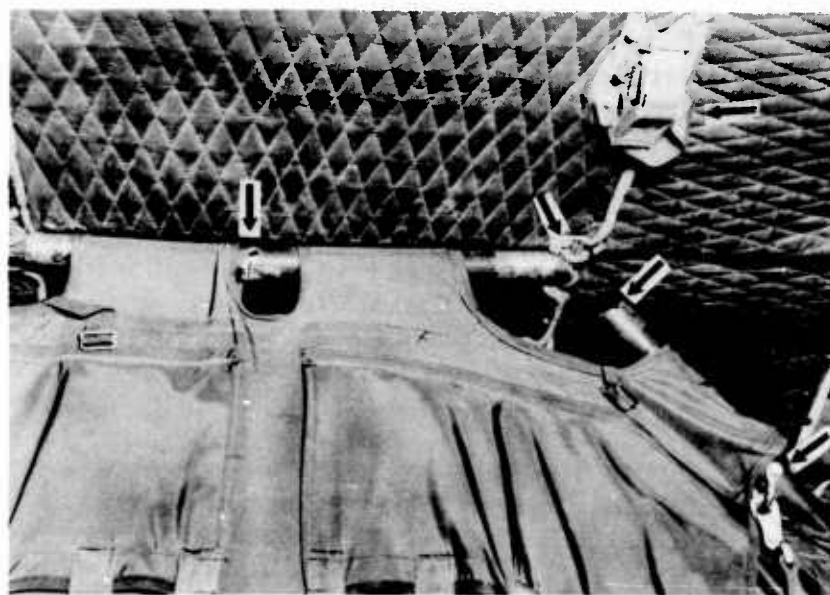
Figure 9. Typical Troop Seat Failure.

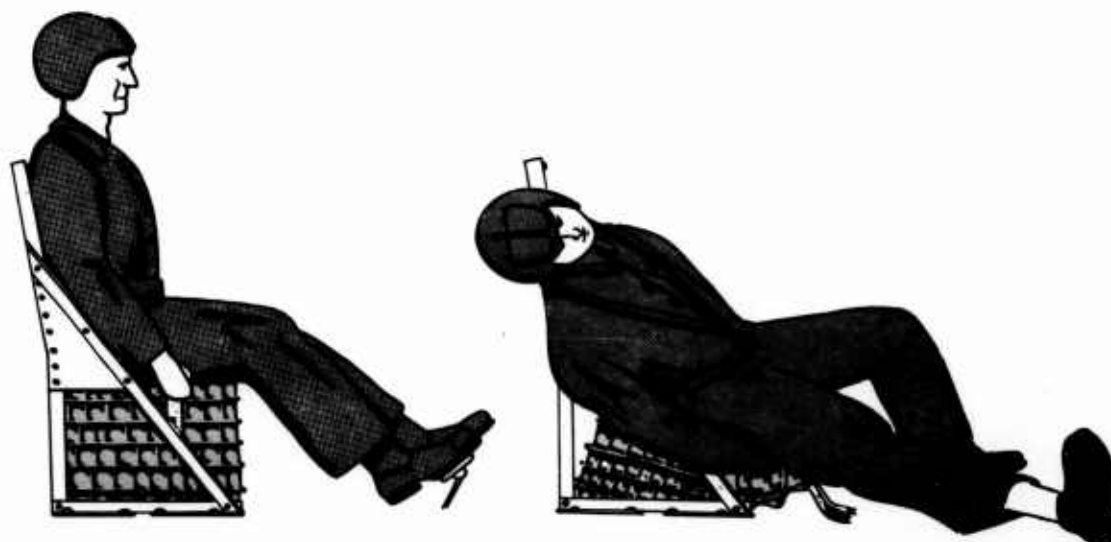
A second experiment relating to the crew seat problem was conducted in the drop test of 9 August 1961. This was the construction of a crew seat frame and the utilization of paper honeycomb (5 layers) as a replacement for the seat pan. A dummy, comparable to that in the pilot's seat, was placed in this improvised seating arrangement with seat belt and shoulder harness anchored to basic structure. Collapsing of the honeycomb occurred as predicted (see Figures 10, 11, and 12), and the vertical accelerations measured in the pelvic region were reduced substantially, probably from nonsurvivable to survivable limits; whereas the peak accelerations on the pilot in the standard seat reached 80-90G, the peak accelerations in the honeycomb seat reached only 30-35G, a 62 percent reduction.

Figure 11. Collapse Sketch of Honeycomb Seat Pan in T-4.

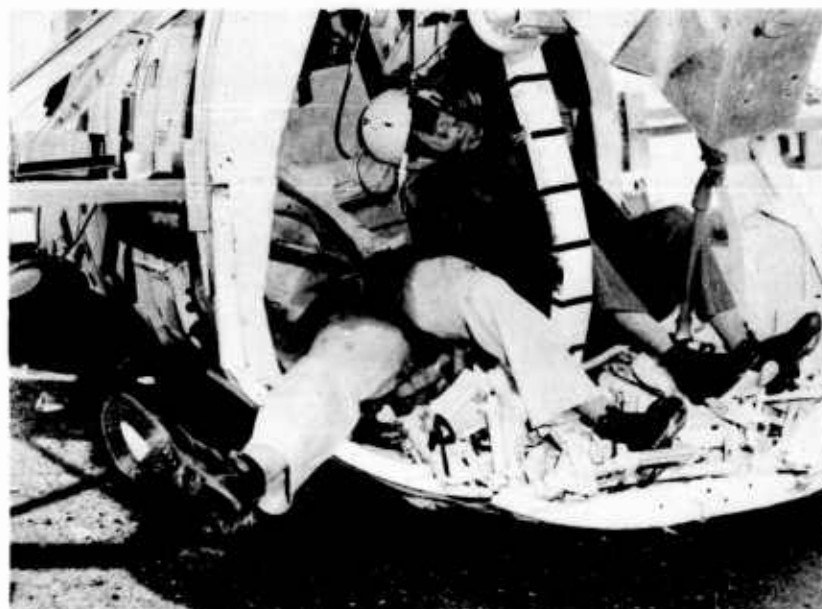
Figure 12. Collapse of Honeycomb Seat Pan in T-4.

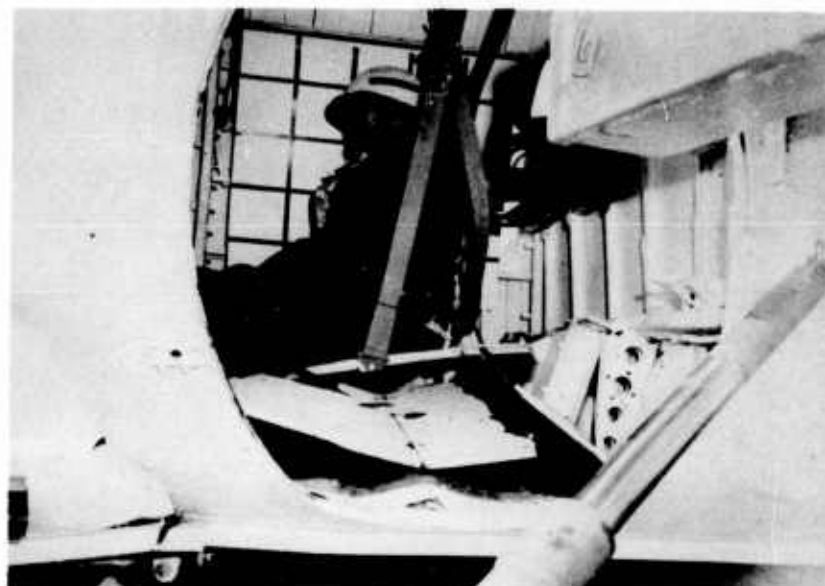
Figure 17. Experimental Troop Seat After Crash Test.

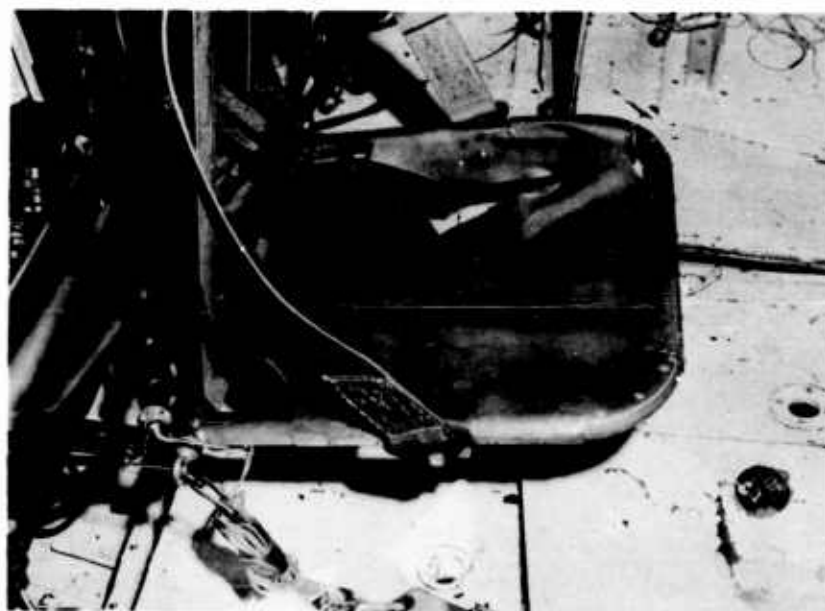
Figure 18. Experimental Troop Seat After Crash Test.

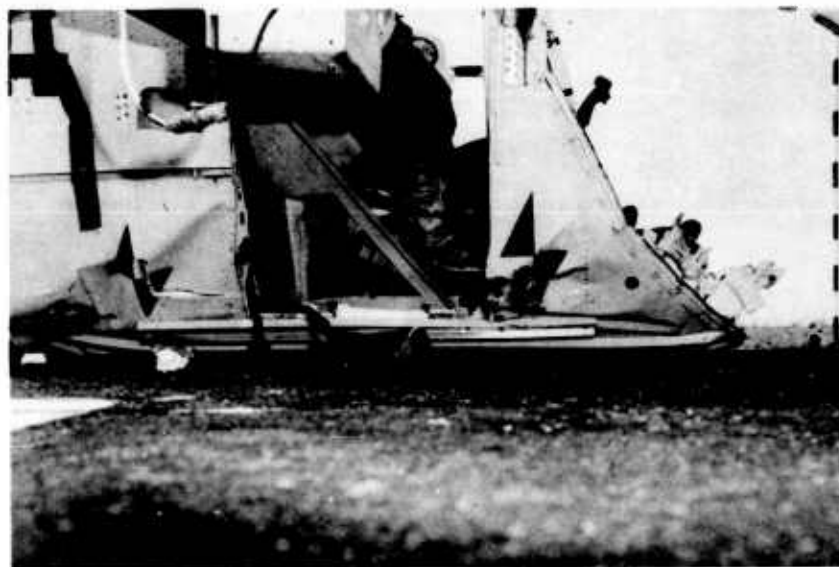
Figure 34. Paper Honeycomb Seat Pan (T-4)  
After Drop.
